Assessing Channel Erosion in Arcade Creek

eric berntsen

stormwater program / SWRCB

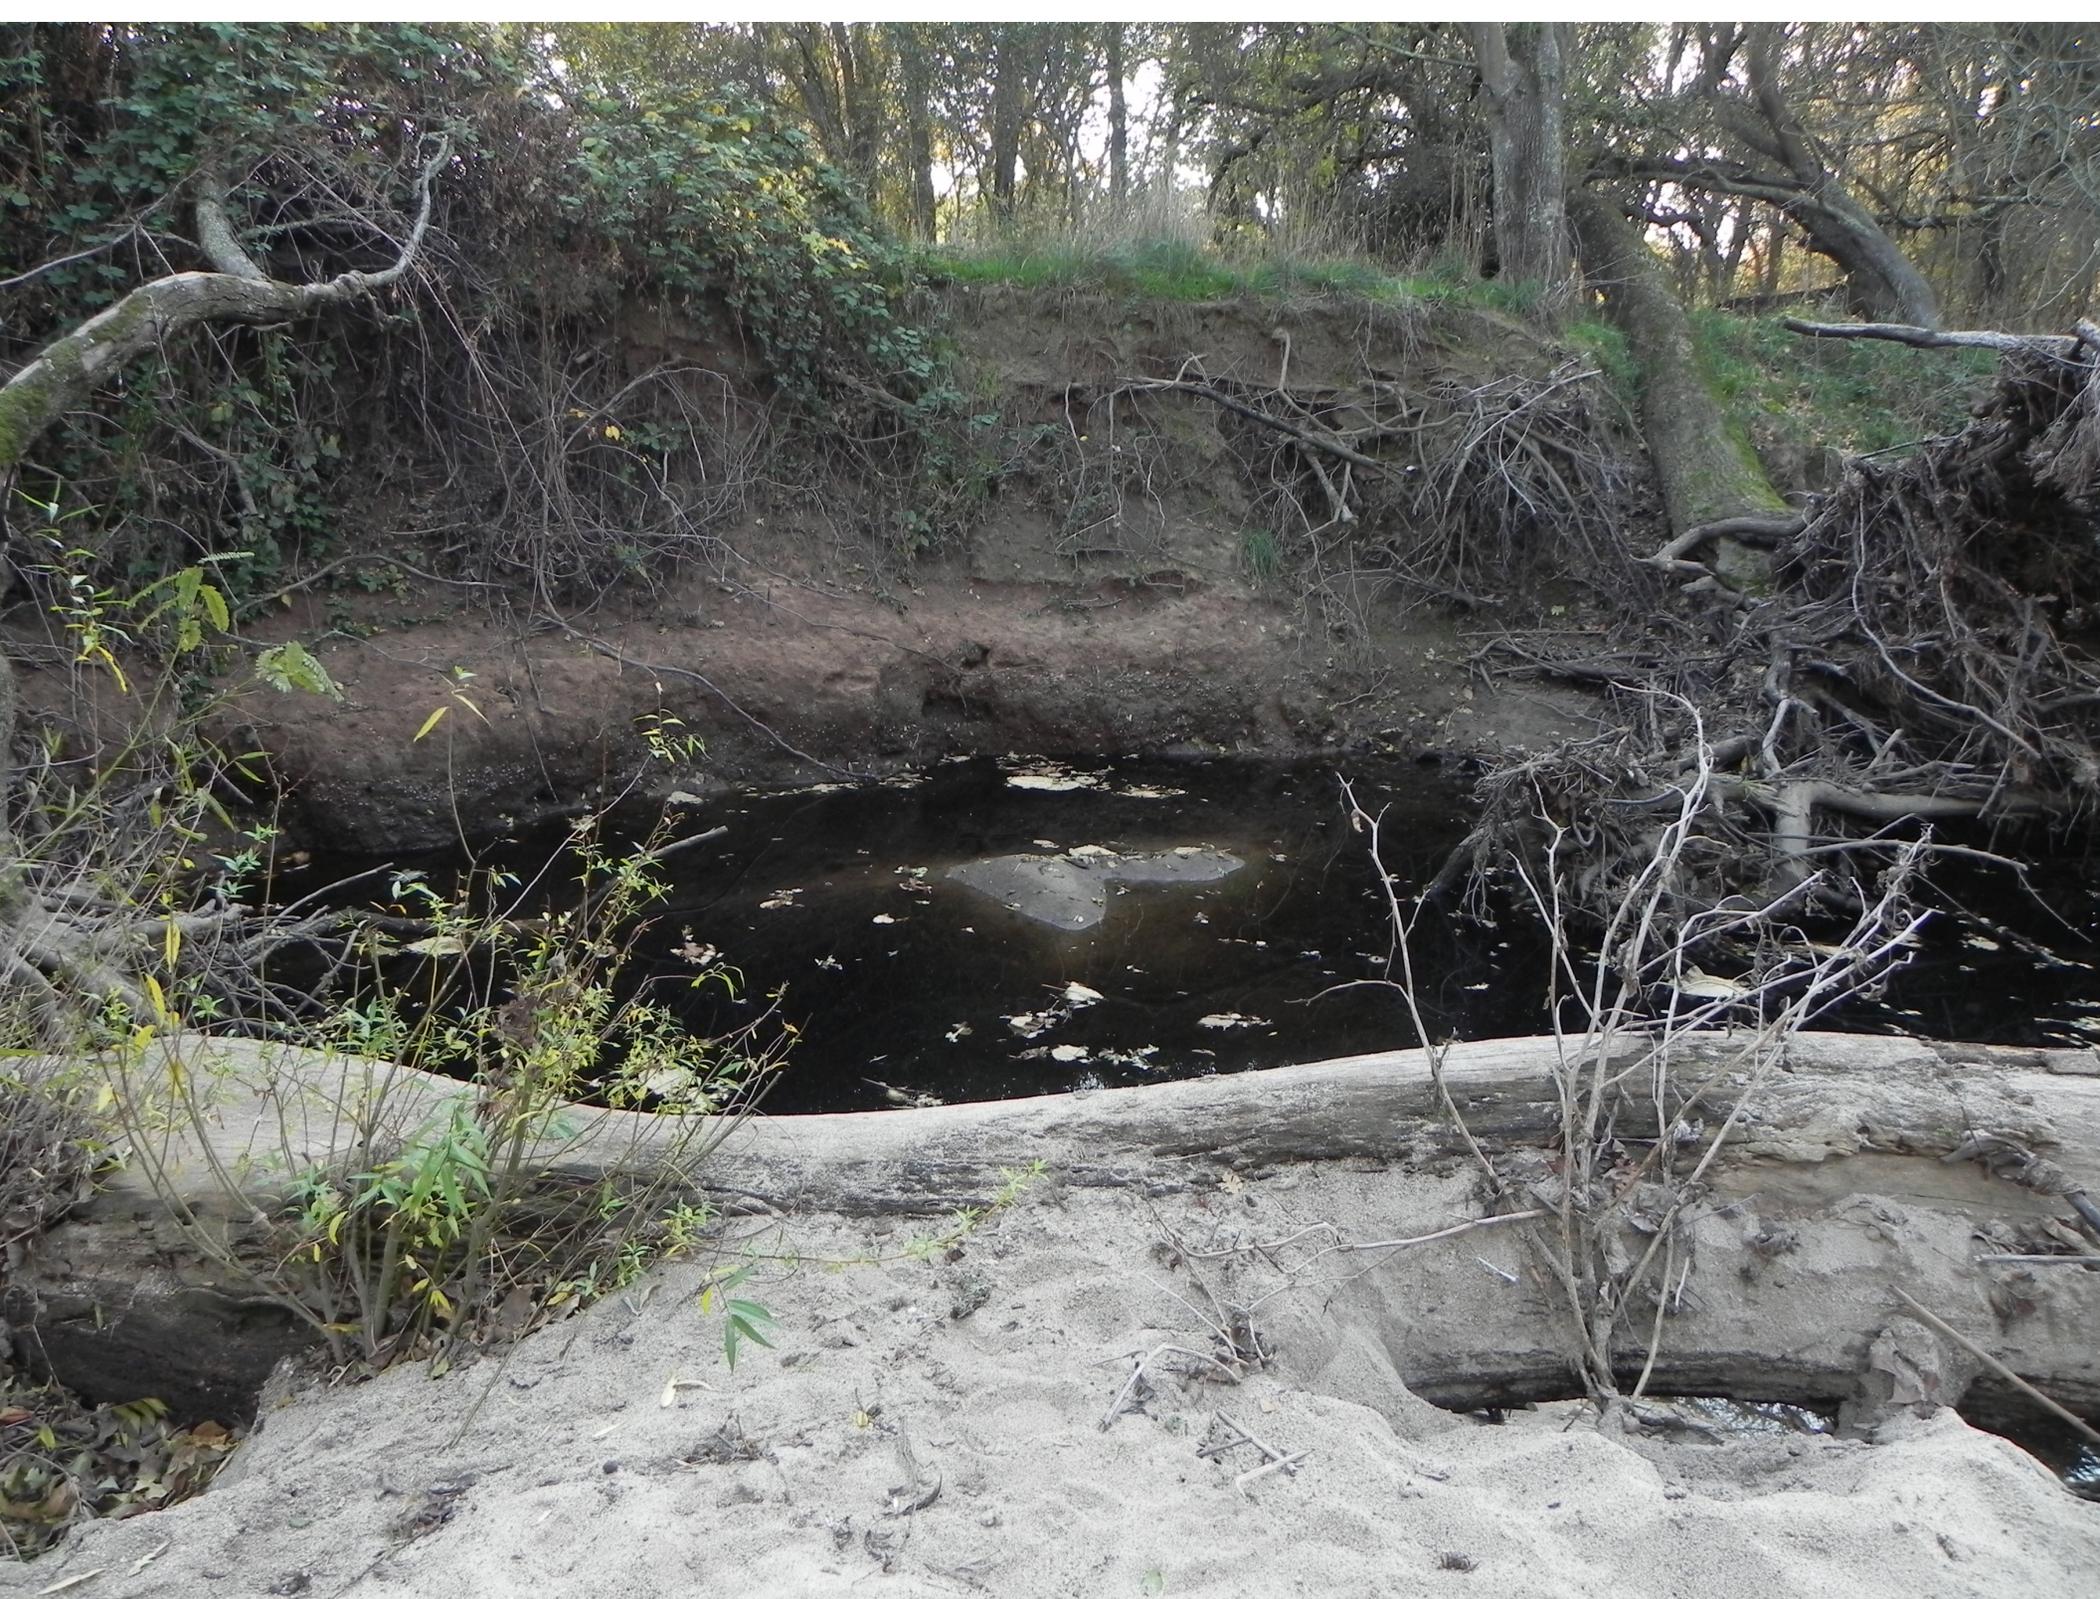
| Channel Stability Index Rating¹ | | | | | | Score |
| Total Score = | | | | | | 30 |

¹ The length of stream channel to be analyzed depends on the width and length of the channel. Data shall be collected at two sites at each transect within a distance of 30 bankfull channel widths. The sites shall be located in portions of the channel reach with relatively uniform width and gradient. For example, a 20 foot-wide channel would require data from at least two sites within a 600 foot distance. If sections of channel within the 30 bankfull width distance are immediately upstream or downstream of steps, culverts, grade controls, tributary junctions, or other features and structures that significantly affect the shape and behavior of the channel, a distance of longer than 30 bankfull widths must be analyzed. A total score of 10 or less indicates a stable channel; scores of 20 or more are indicative of severe instability.
