**Assessing Channel Erosion in Arcade Creek  
Sacramento County, California  
Eric Berntsen  
GEOG 342 Final Project  
ekberntsen@comcast.net**

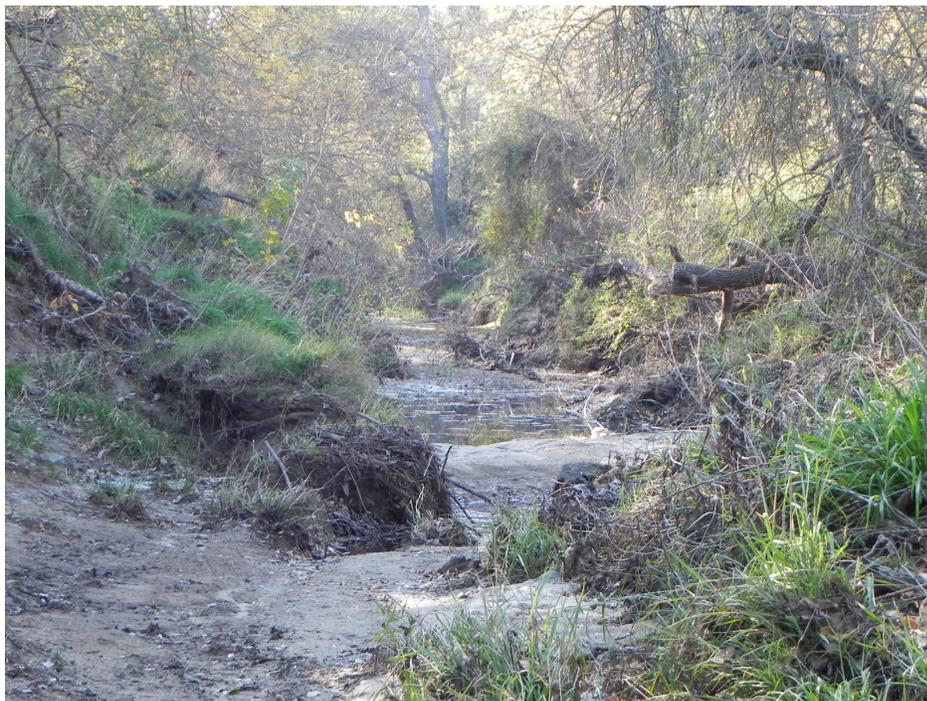
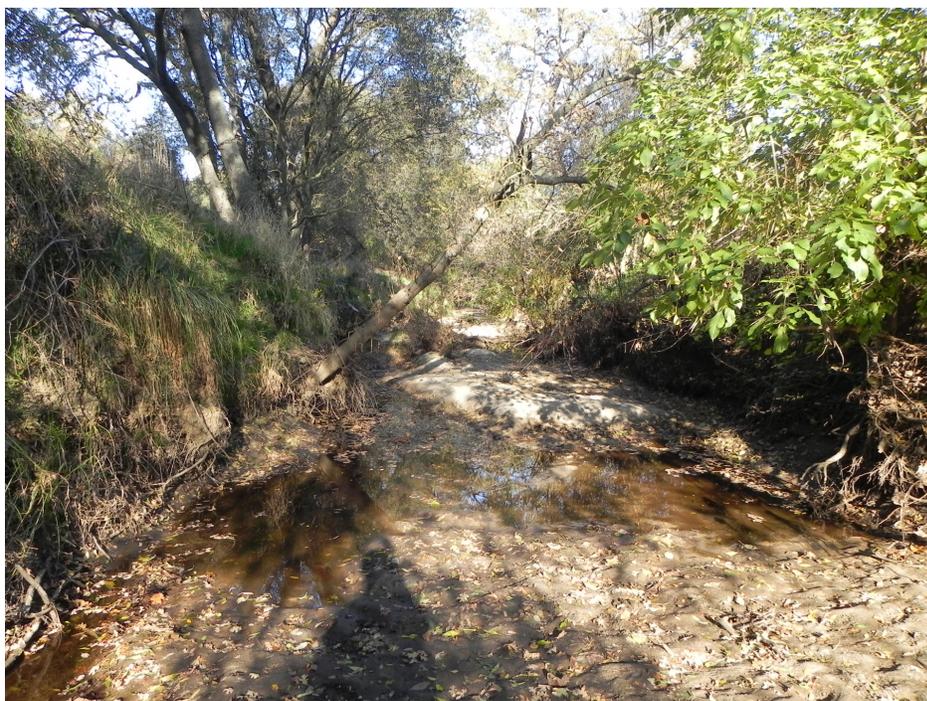
Photo 1 – Looking west from Training Sites in Figure 5

Images were generated for all isocluster unsupervised classifications. Figure 4 shows the image from the four class isocluster unsupervised classification. Table 1 shows the channel stability index rating calculated for the area between the two training sites in Figure 5. Photo 1 was taken looking west and Photo 2 was taken looking east. The channel stability index rating of 27 indicates severe instability (Simon and Downs 1995) and the photos indicate severe incision and bank erosion. Figure 5 also shows the image generated from the Maximum Likelihood Estimator used on the five class unsupervised image. Note that the spectral signatures for the pavement on the bridge and the channel erosion site are the same, suggesting that not enough classes were used in the unsupervised classification.

Left	2	1.5	1	0.5	0	0.5
Right	2	1.5	1	0.5	0	0.5
<b>8. Occurrence of bank accretion</b> (Percent of each bank with fluvial deposition)						
	0-10%	11-25%	26-50%	51-75%	76-100%	
Left	2	1.5	1	0.5	0	0.5
Right	2	1.5	1	0.5	0	0.5
<b>9. Stage of channel evolution</b>						
I	II	III	IV	V	VI	
0	1	2	4	3	1.5	4
<b>10. Composition of adjacent side slope</b>						
	N/A	Bedrock	Boulders	Gravel-SP	Fines	
Left	0	0.5	1	1.5	2	2
Right	0	0.5	1	1.5	2	2
<b>11. Percent of slope (length) contributing sediment</b>						
	0-10%	11-25%	26-50%	51-75%	76-100%	
Left	0	0.5	1	1.5	2	0
Right	0	0.5	1	1.5	2	0
<b>12. Severity of side-slope erosion</b>						
	None	Low	Moderate	High		
Left	0	0.5	1.5	2		1.5
Right	0	0.5	1.5	2		1.5
					<b>Total Score =</b>	<b>27</b>

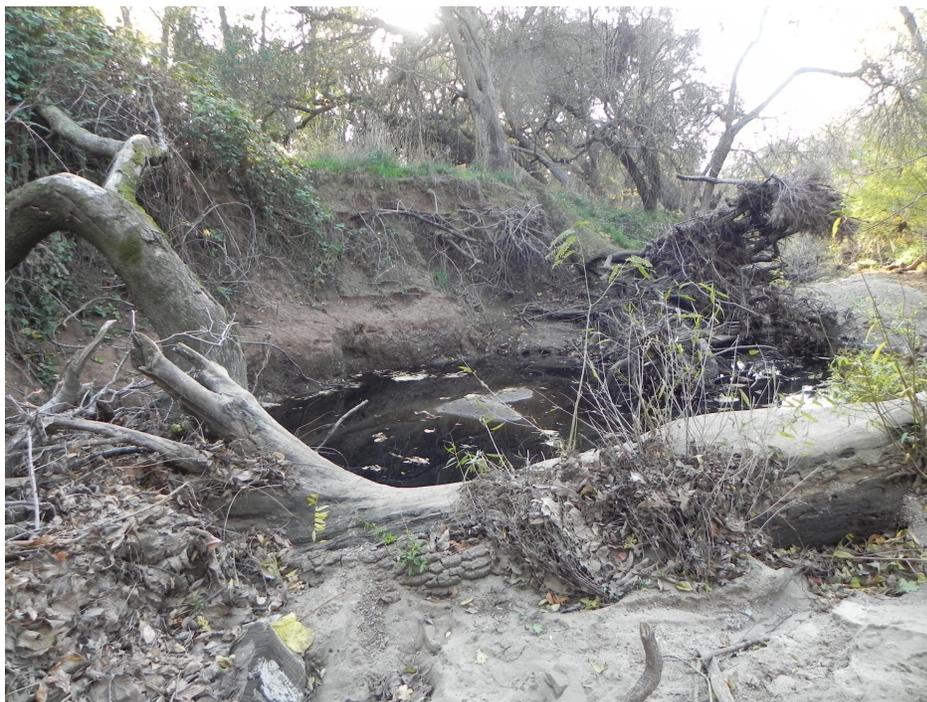
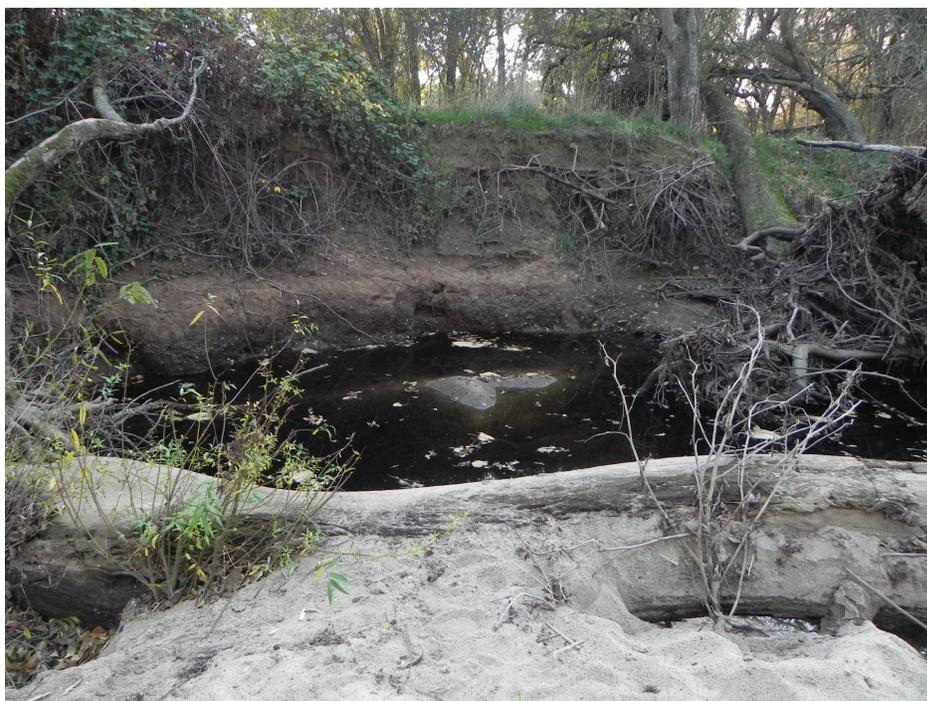
Photo 3 – Looking south from Training Sites in Figure 6

Table 2 shows the channel stability index rating calculated for the area between the two training sites in Figure 6. Photos 3 and 4 were taken looking south from the north training site. The channel stability index rating of 30 indicates severe instability and the photos indicate severe incision, scouring, deposition and bank erosion.

Left	2	1.5	1	0.5	0	0.5
Right	2	1.5	1	0.5	0	0.5
<b>8. Occurrence of bank accretion</b> (Percent of each bank with fluvial deposition)						
	0-10%	11-25%	26-50%	51-75%	76-100%	
Left	2	1.5	1	0.5	0	0.5
Right	2	1.5	1	0.5	0	0.5
<b>9. Stage of channel evolution</b>						
I	II	III	IV	V	VI	
0	1	2	4	3	1.5	4
<b>10. Composition of adjacent side slope</b>						
	N/A	Bedrock	Boulders	Gravel-SP	Fines	
Left	0	0.5	1	1.5	2	2
Right	0	0.5	1	1.5	2	2
<b>11. Percent of slope (length) contributing sediment</b>						
	0-10%	11-25%	26-50%	51-75%	76-100%	
Left	0	0.5	1	1.5	2	0.5
Right	0	0.5	1	1.5	2	0.5
<b>12. Severity of side-slope erosion</b>						
	None	Low	Moderate	High		
Left	0	0.5	1.5	2		2
Right	0	0.5	1.5	2		2
<b>Total Score =</b>						<b>30</b>
