**Assessing Channel Erosion in Arcade Creek  
Sacramento County, California  
Eric Berntsen  
GEOG 342 Final Project  
ekberntsen@comcast.net**

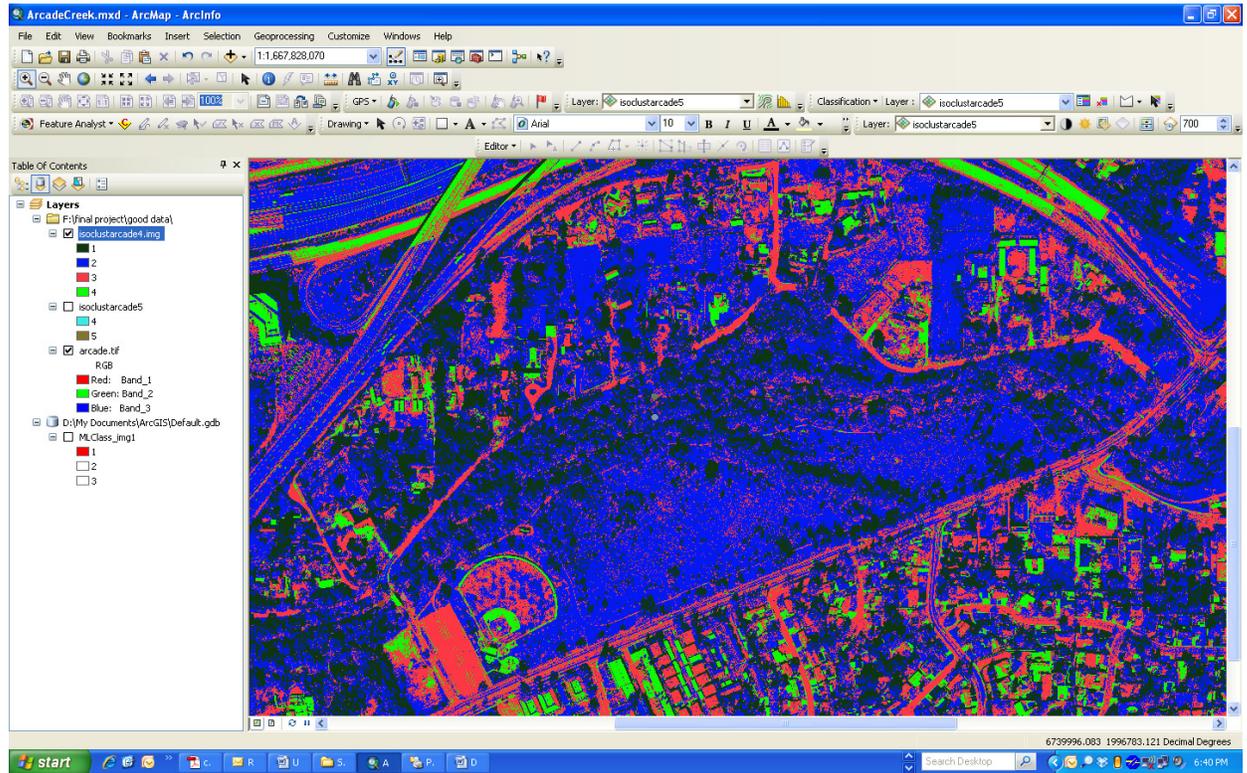
Figure 4 – Four class isocluster unsupervised classification image

Images were generated for all isocluster unsupervised classifications. Figure 4 shows the image from the four class isocluster unsupervised classification. Table 1 shows the channel stability index rating calculated for the area between the two training sites in Figure 5. Photo 1 was taken looking west and Photo 2 was taken looking east. The channel stability index rating of 27 indicates severe instability (Simon and Downs 1995) and the photos indicate severe incision and bank erosion. Figure 5 also shows the image generated from the Maximum Likelihood Estimator used on the five class unsupervised image. Note that the spectral signatures for the pavement on the bridge and the channel erosion site are the same, suggesting that not enough classes were used in the unsupervised classification.

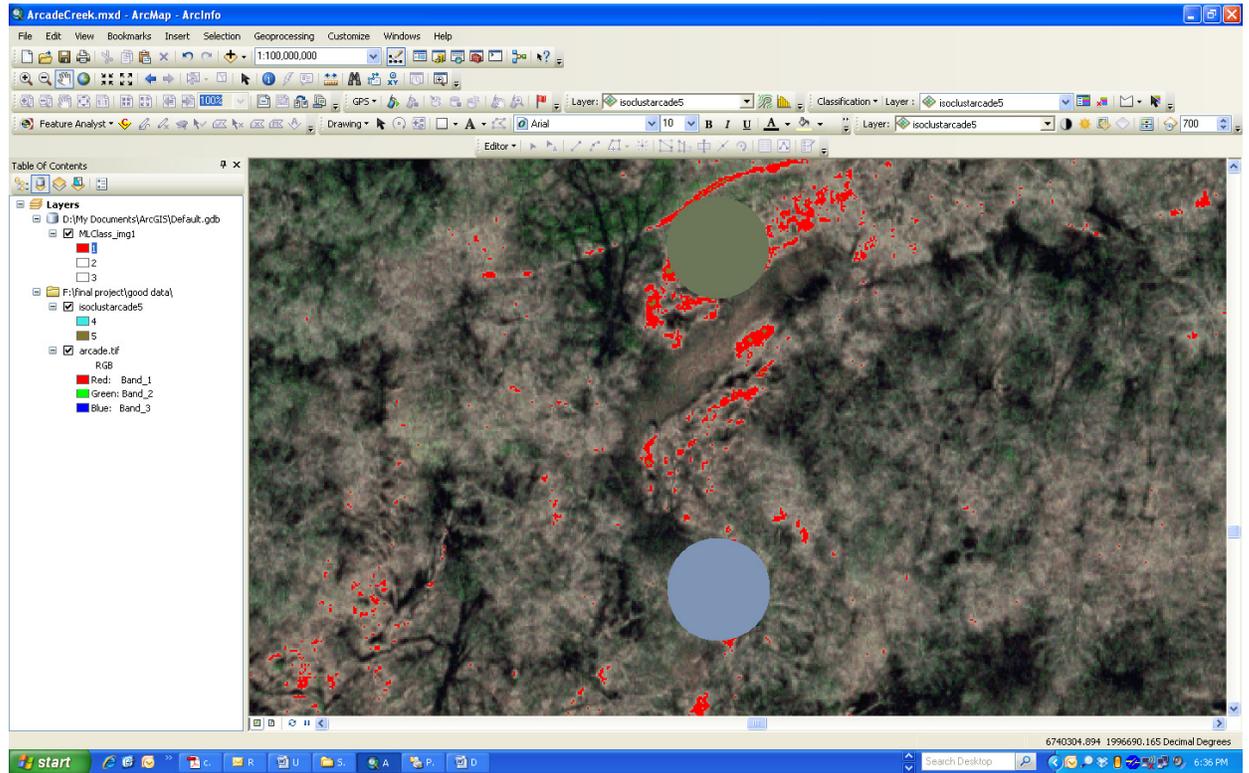
Figure 6 – Training sets and five class supervised classification image (2)

Table 2 shows the channel stability index rating calculated for the area between the two training sites in Figure 6. Photos 3 and 4 were taken looking south from the north training site. The channel stability index rating of 30 indicates severe instability and the photos indicate severe incision, scouring, deposition and bank erosion.

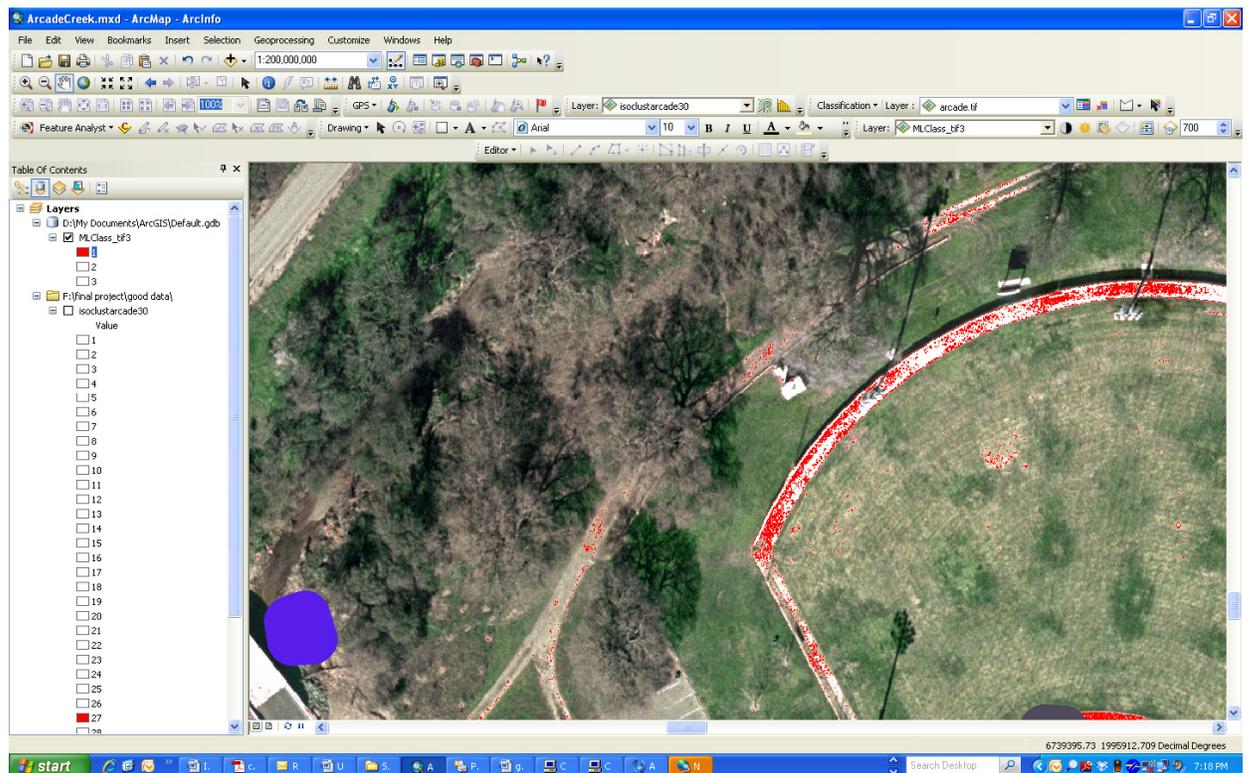
Figure 7 – Training sets and 30 class supervised classification image

Figure 7 shows the image generated from the Maximum Likelihood Estimator used on the 30 class unsupervised image. The training sites were located on channel erosion areas. Note that the spectral signatures for the pavement on the bridge and the channel erosion site are not the same. However, there are very few pixels located on the erosion areas. This suggests that the image resolution may not be adequate to distinguish areas of exposed soil that are indicative of channel erosion. The same pattern is shown in Figure 8.
